LANDING GEAR INDICATIONS

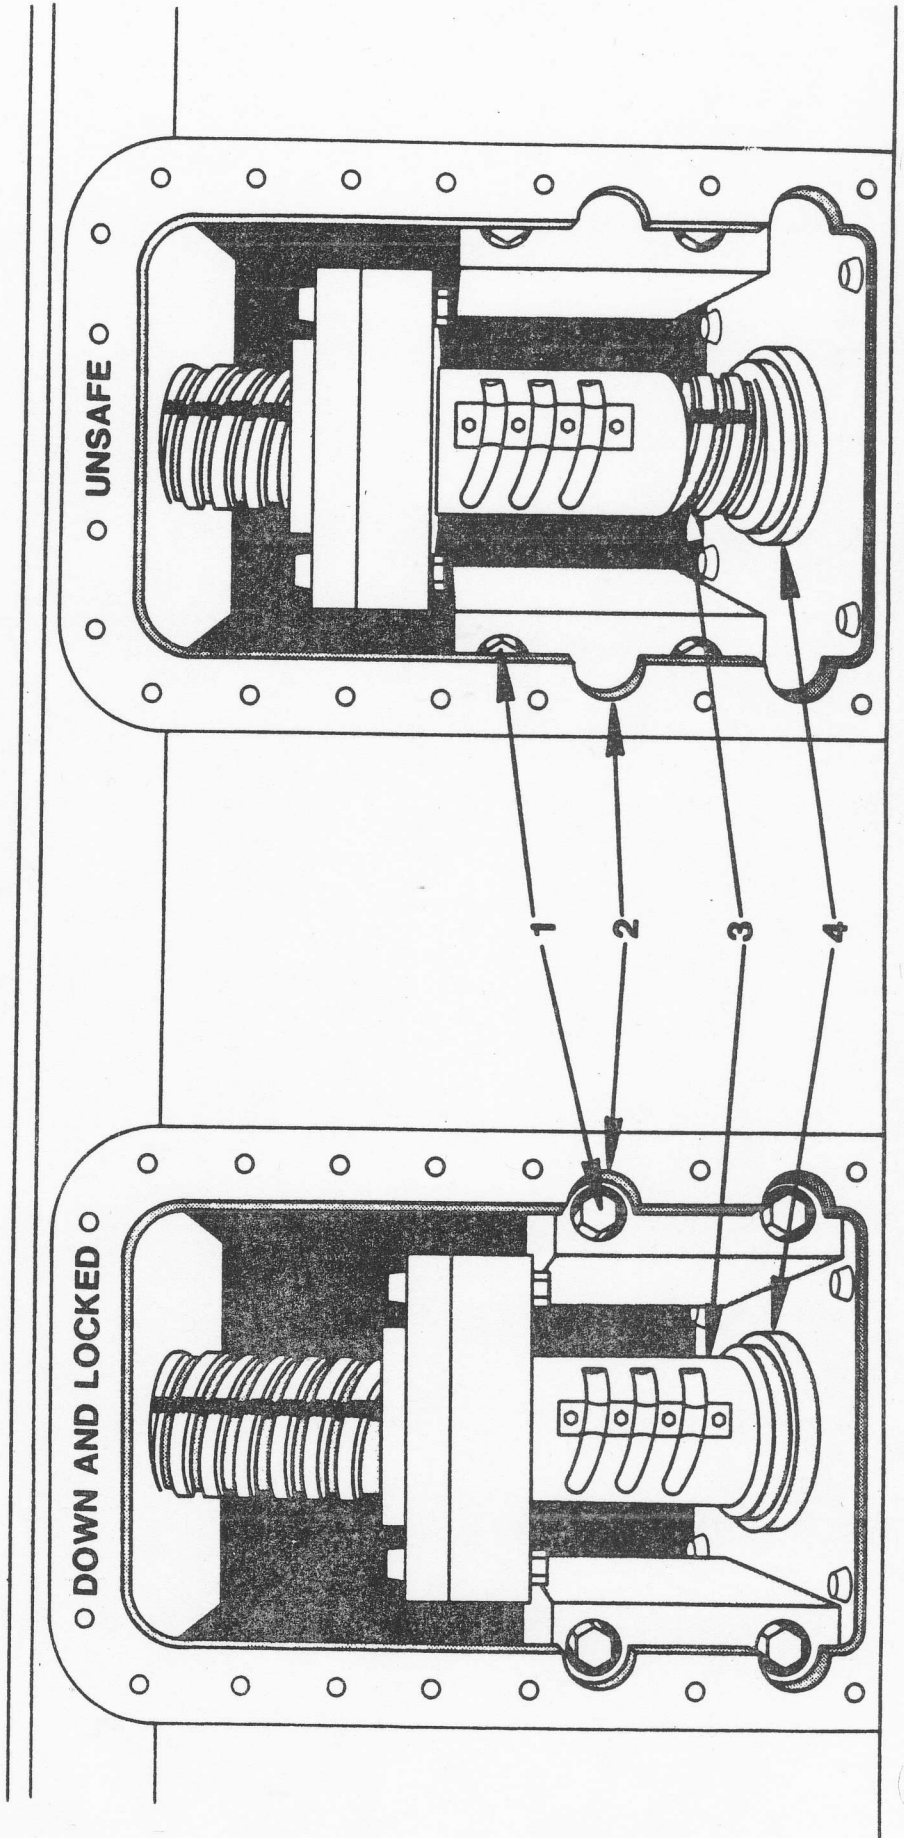
THE FIGURE ON THE LEFT IS A DOWN AND LOCKED MAIN LANDING GEAR WITH INSPECTION WINDOW AND DUAL RAIL COVER REMOVED. NOTE THAT THE SHOE BOLTS (1), ARE CENTERED WITHIN THE BOLT RECESSES (2), AND THAT THE BOTTOM OF THE BALL NUT (3), CONTACTS THE BUMPER STOP (4).

THE FIGURE ON THE RIGHT DEPICTS THE LANDING GEAR IN AN UNSAFE CONDITION - NOTE THE MISALIGNMENT OF THE SHOE BOLTS WITH THEIR RESPECTIVE RECESSES AND THE VISIBLE JACKSCREW THREADS BETWEEN BALL NUT AND BUMPER STOP.
